INSTALLATION RESTORATION  
PROGRAM RECORDS SEARCH

FOR

AIR FORCE PLANT 4, TEXAS

August 1984

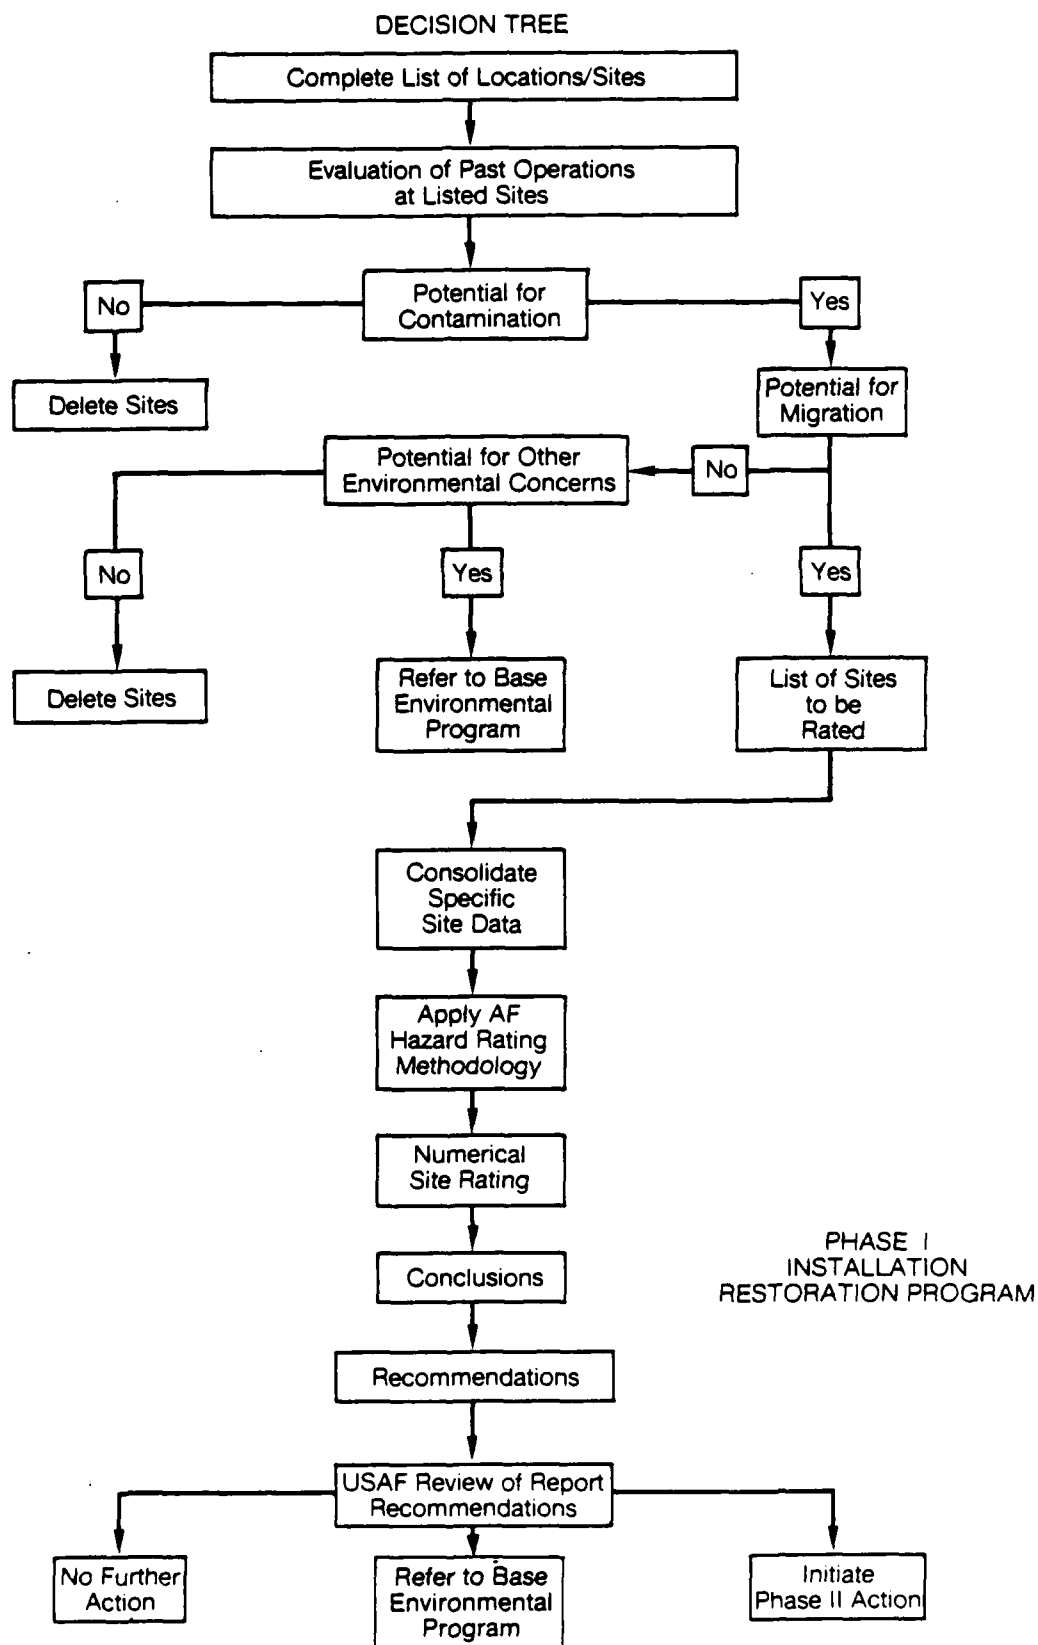
**FIGURE 3.**  
Records Search Methodology.

The methodology used in the Air Force Plant 4 records search is shown in Figure 3. First, a review of past and present industrial operations was conducted at the

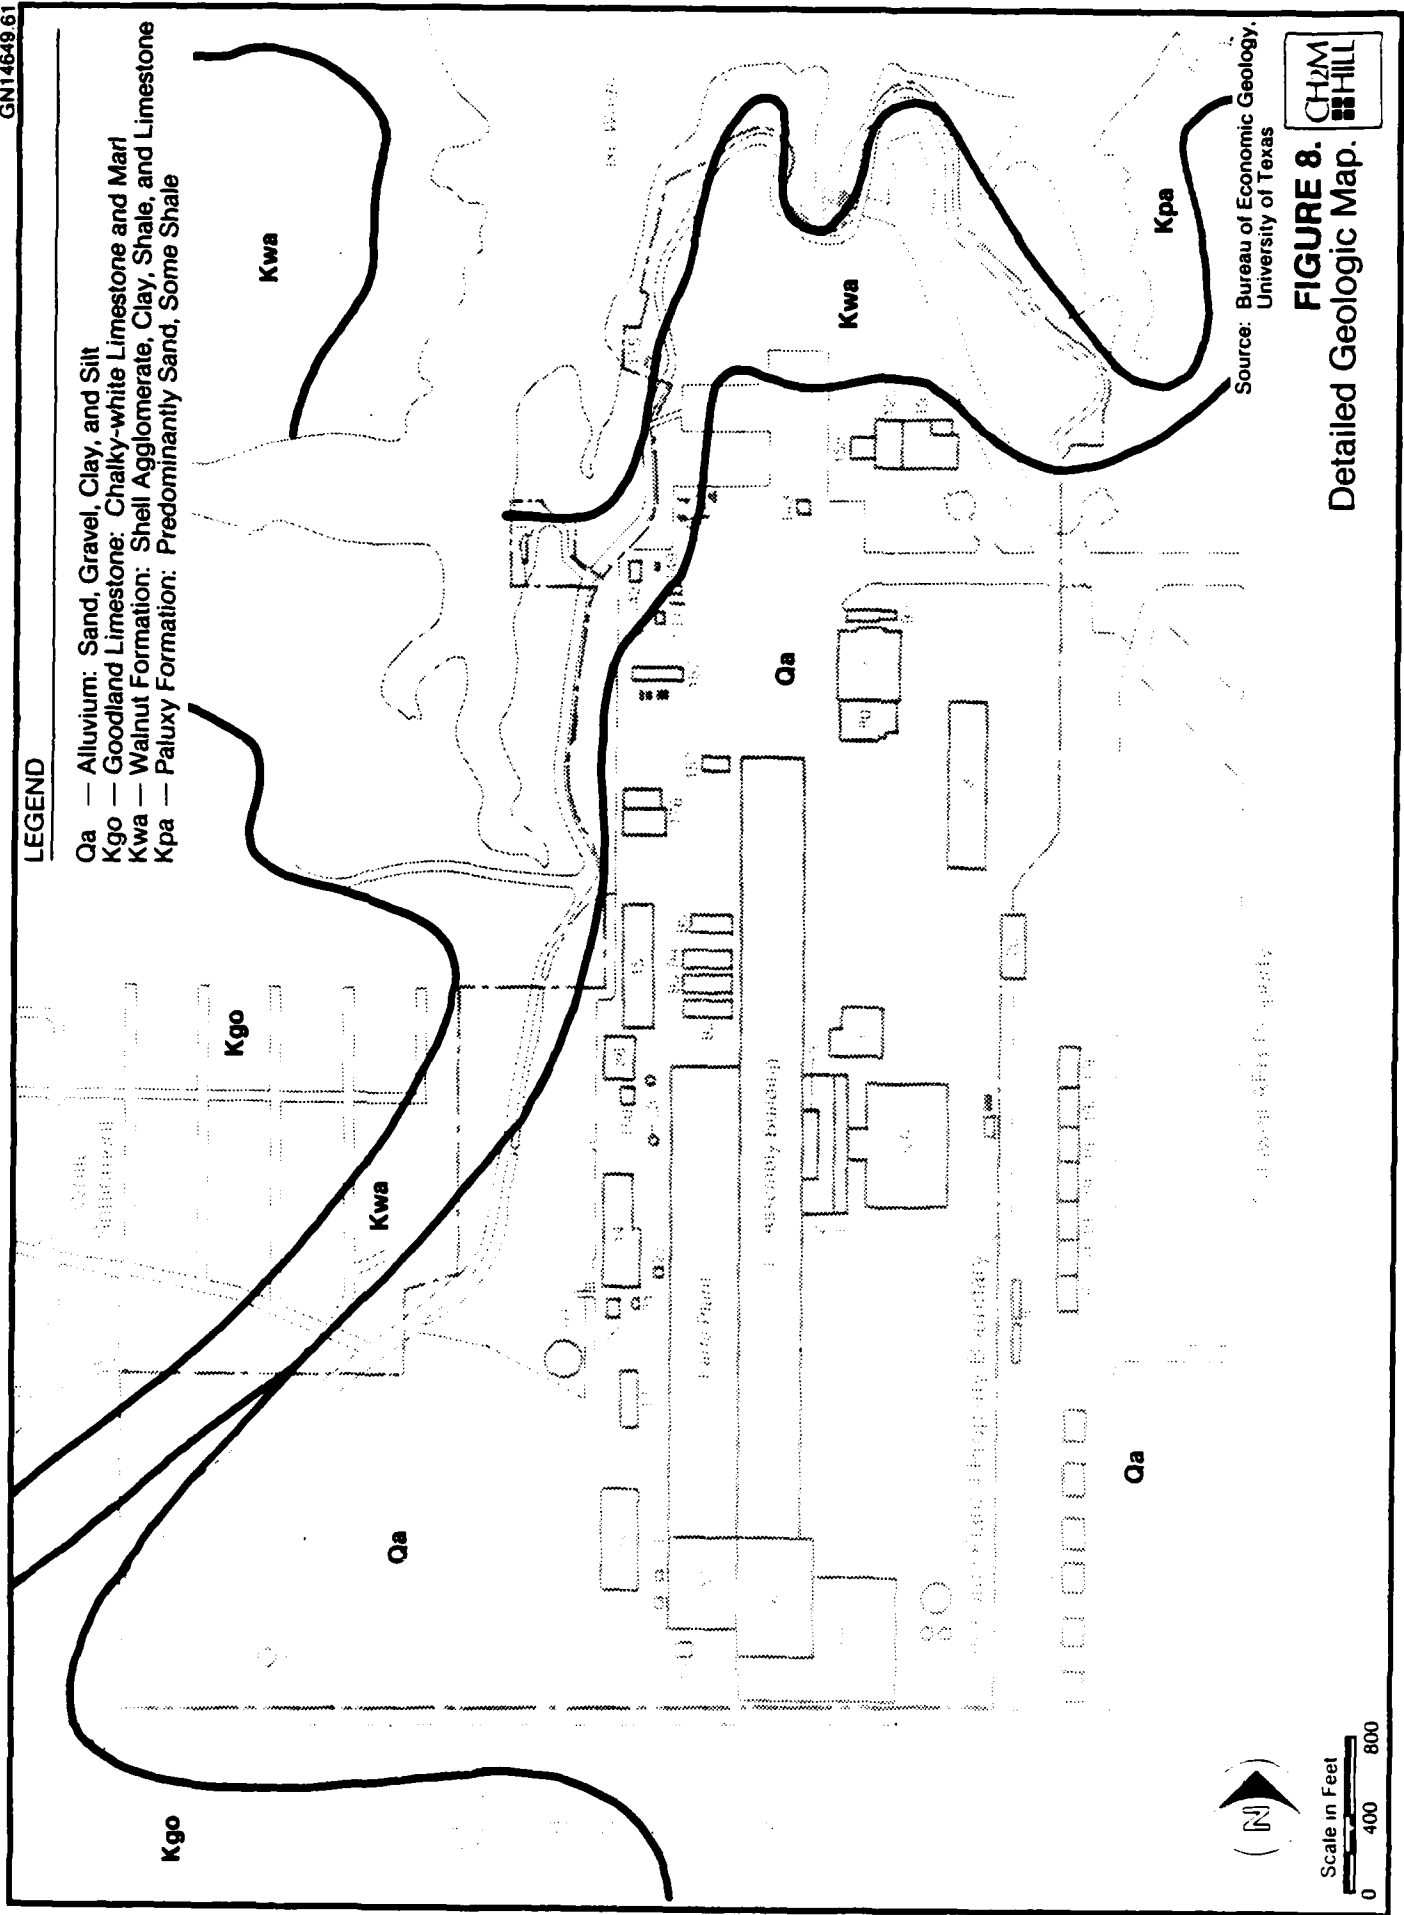
Figure 8 illustrates a more detailed geologic map in the vicinity of Air Force Plant 4. This map shows that most of the plant is covered with alluvium, indicated by the geologic symbol Qa. Only in small sections of Air Force Plant 4 has the alluvium been removed by erosion, exposing the underlying Goodland Limestone (Kgo), or the older Paluxy Formation (Kpa). These formations outcrop along the north and northwest boundary of Air Force Plant 4, adjacent to Meandering Road Creek and Lake Worth.

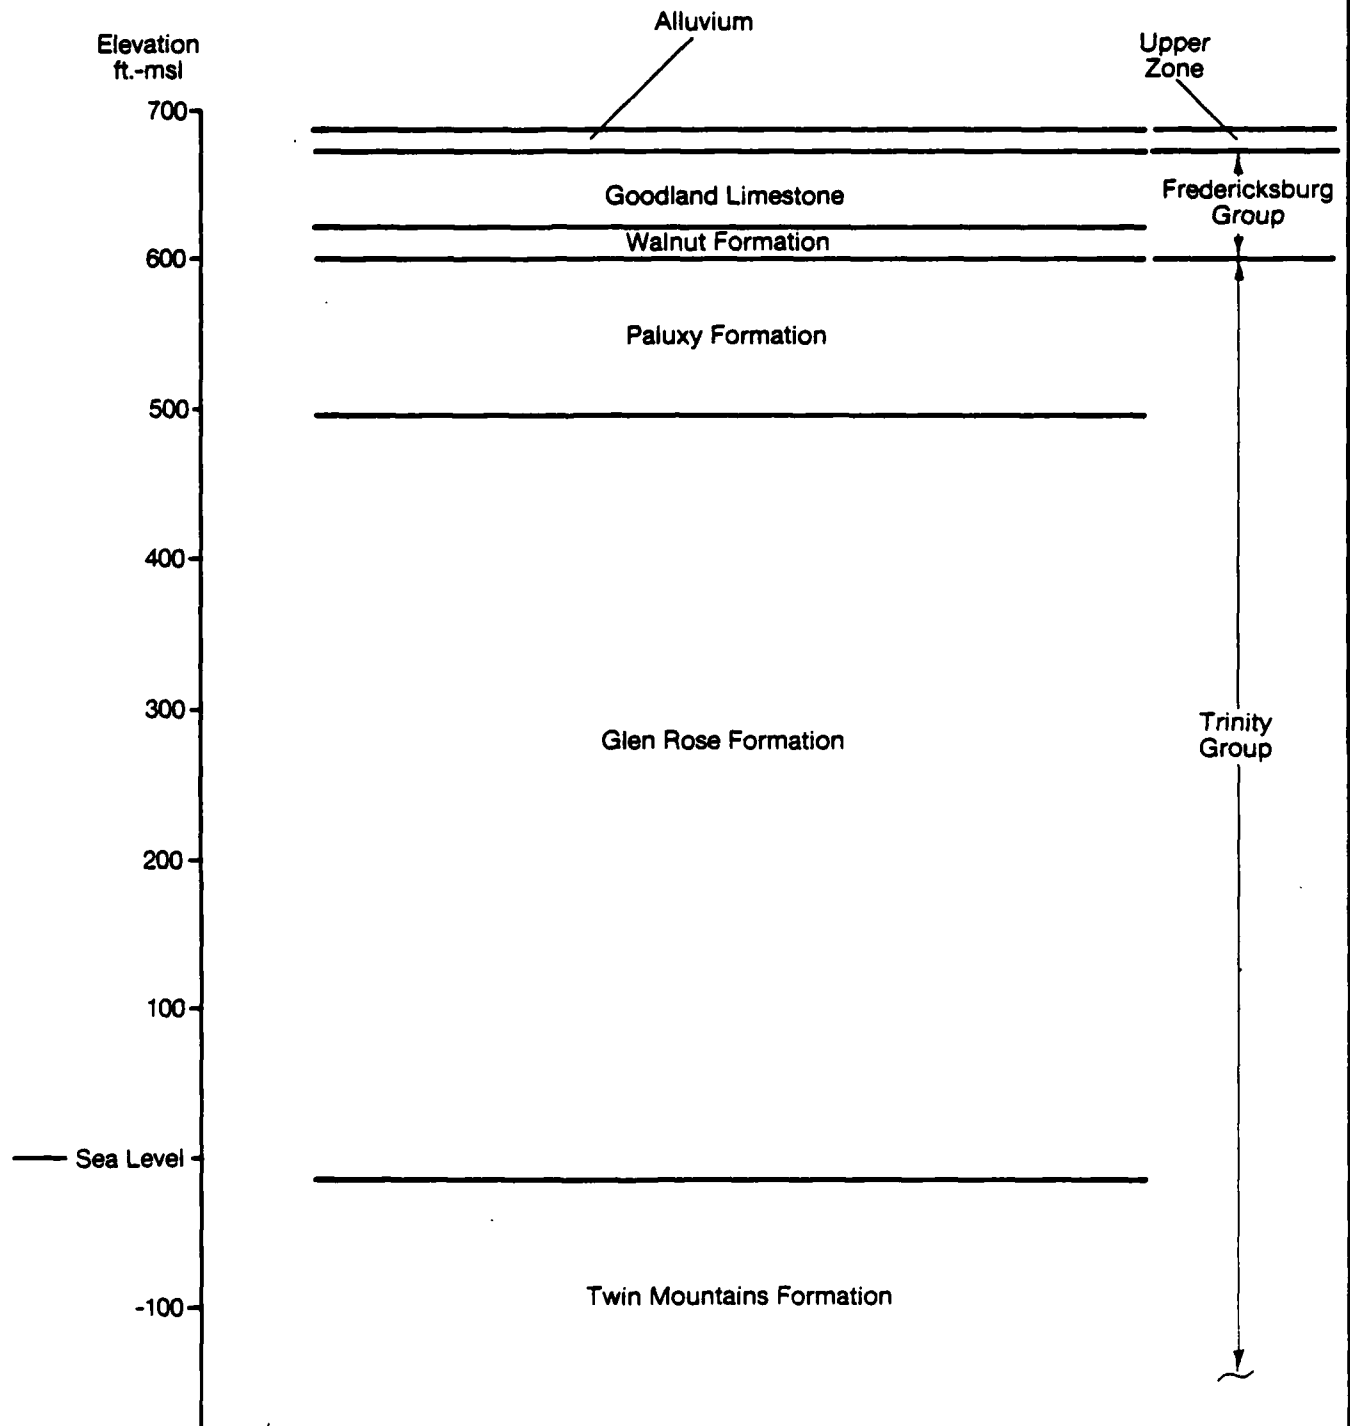
**FIGURE 9.**  
General Geologic Cross Section.

Figure 9 illustrates a general geologic cross section typical of Air Force Plant 4.

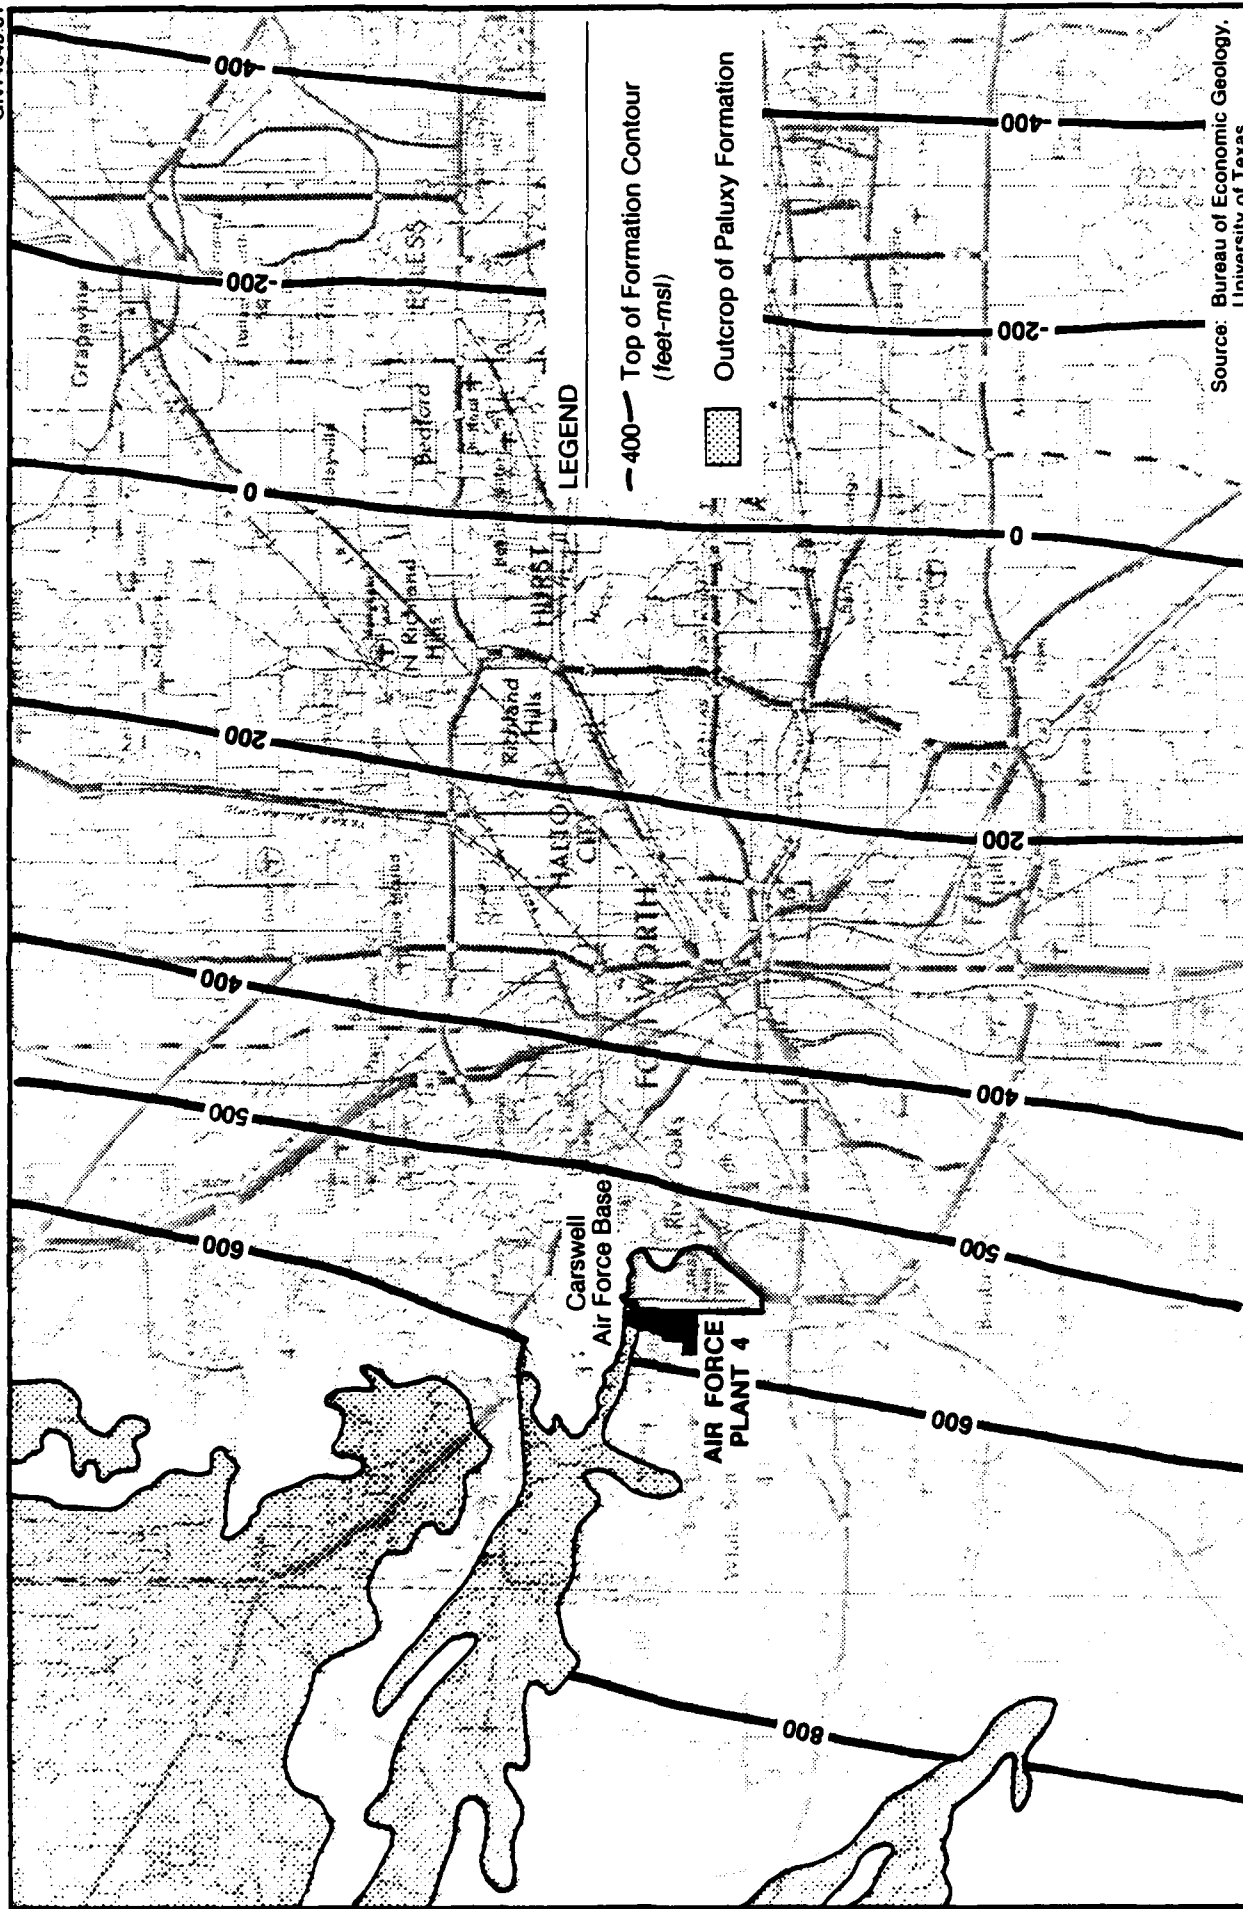
**FIGURE 10.**  
Approximate Altitude of the Top of the Paluxy Formation.

Paluxy sand under artesian conditions. Figure 10 depicts the altitude and configuration at the top of the Paluxy sand. At Air Force Plant 4, the top of the Paluxy occurs at approximately 550 feet msl, or approximately 100 feet below land surface (bls). Figure 11 illustrates the approximate saturated thickness of the Paluxy sand. At Air Force Plant 4 the Paluxy aquifer is approximately 100 feet thick.

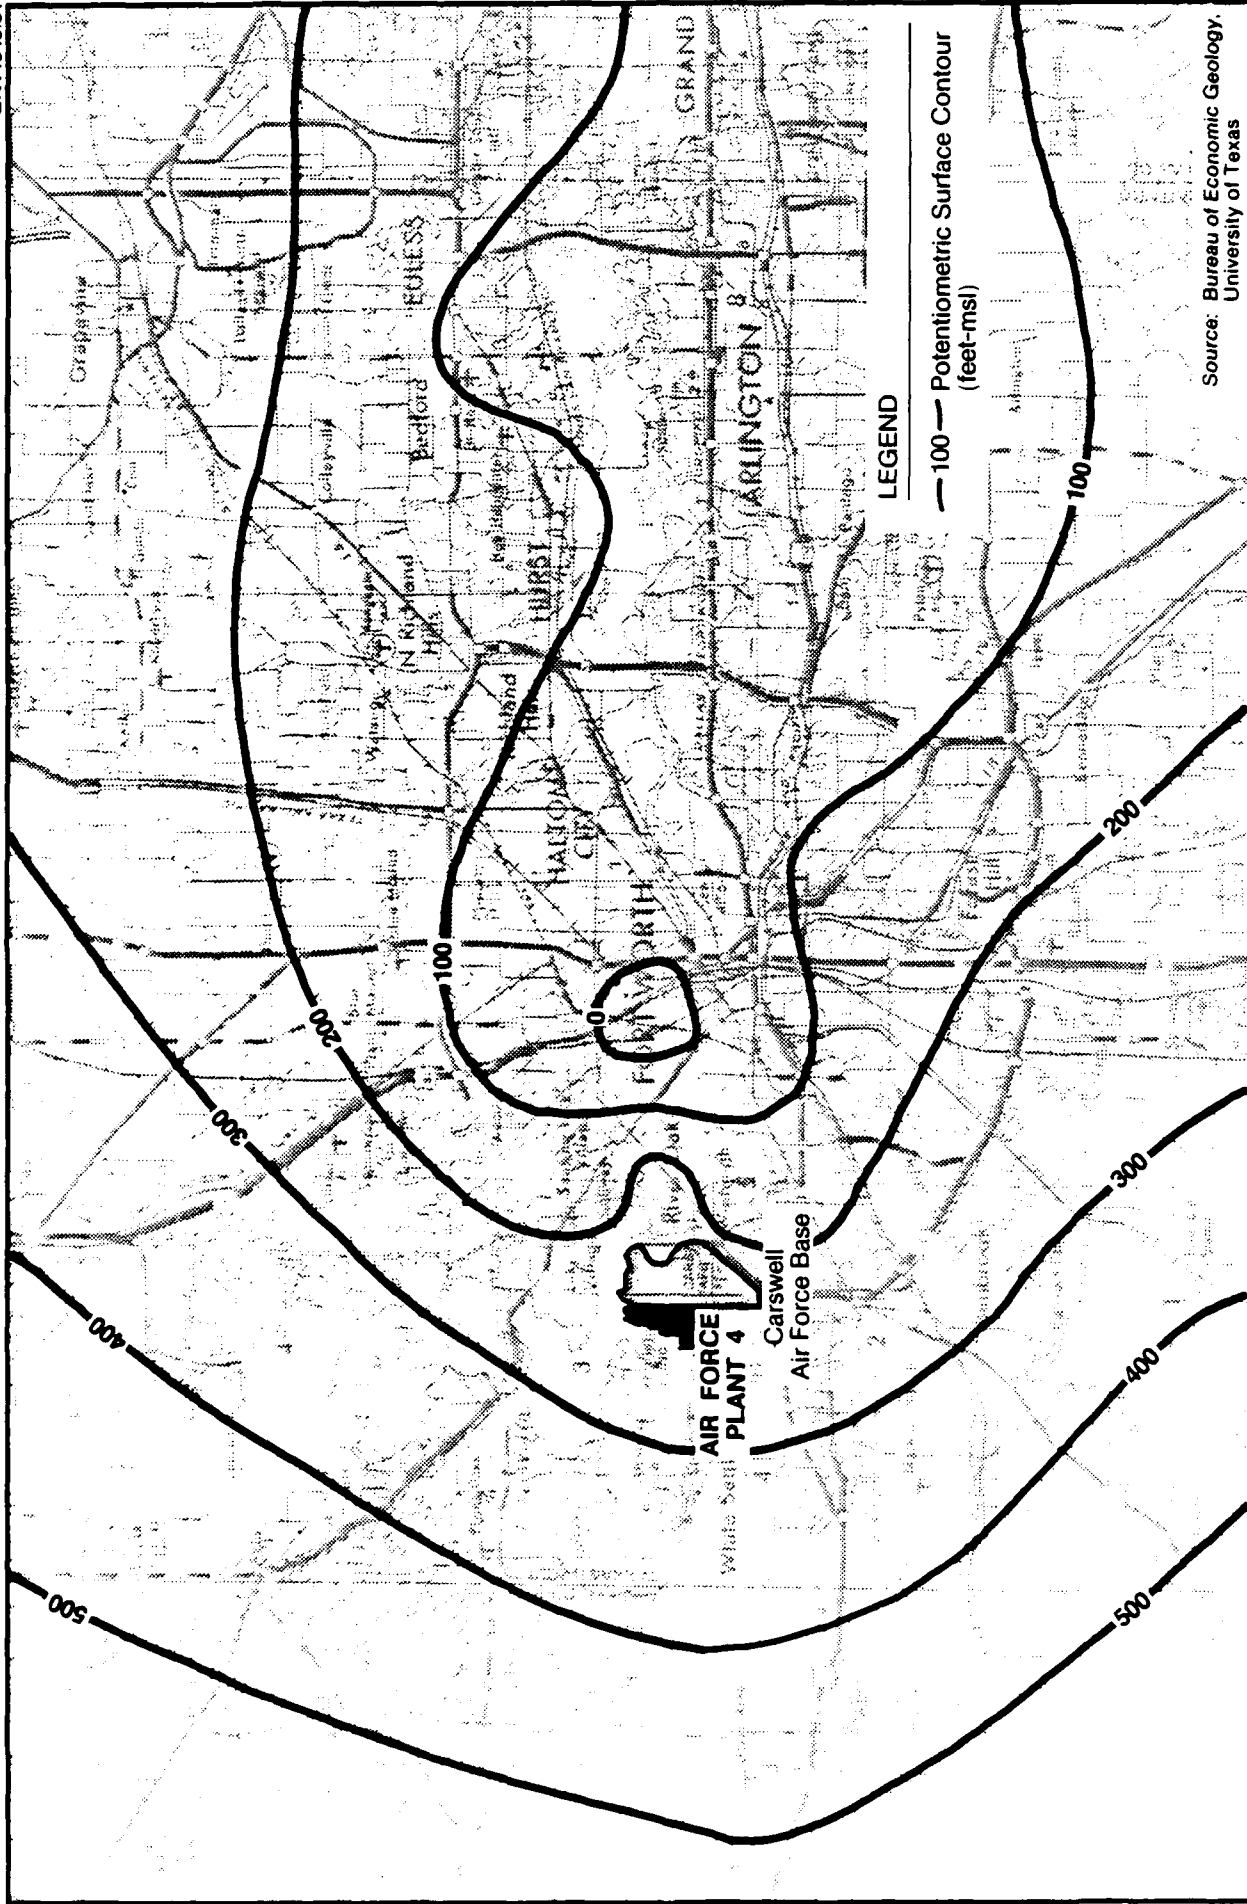
**FIGURE 15.**  
Potentiometric Surface of the Twin Mountains Aquifer, 1955.

Also, like the Paluxy sand, ground-water withdrawals from the Twin Mountains aquifer have resulted in declining water levels. Figure 15 illustrates the 1955 potentiometric surface of the Twin Mountains aquifer. At that time, the potentiometric surface of this aquifer at Air Force Plant 4 was approximately 250-feet msl. Figure 16 illustrates the 1976 potentiometric surface of the same aquifer. In 1976, the potentiometric surface was at elevation 0-feet msl, indicating a decline of approximately 250 feet from 1955 to 1976. Most of the decline was due to ground-water withdrawals for municipal water supply.

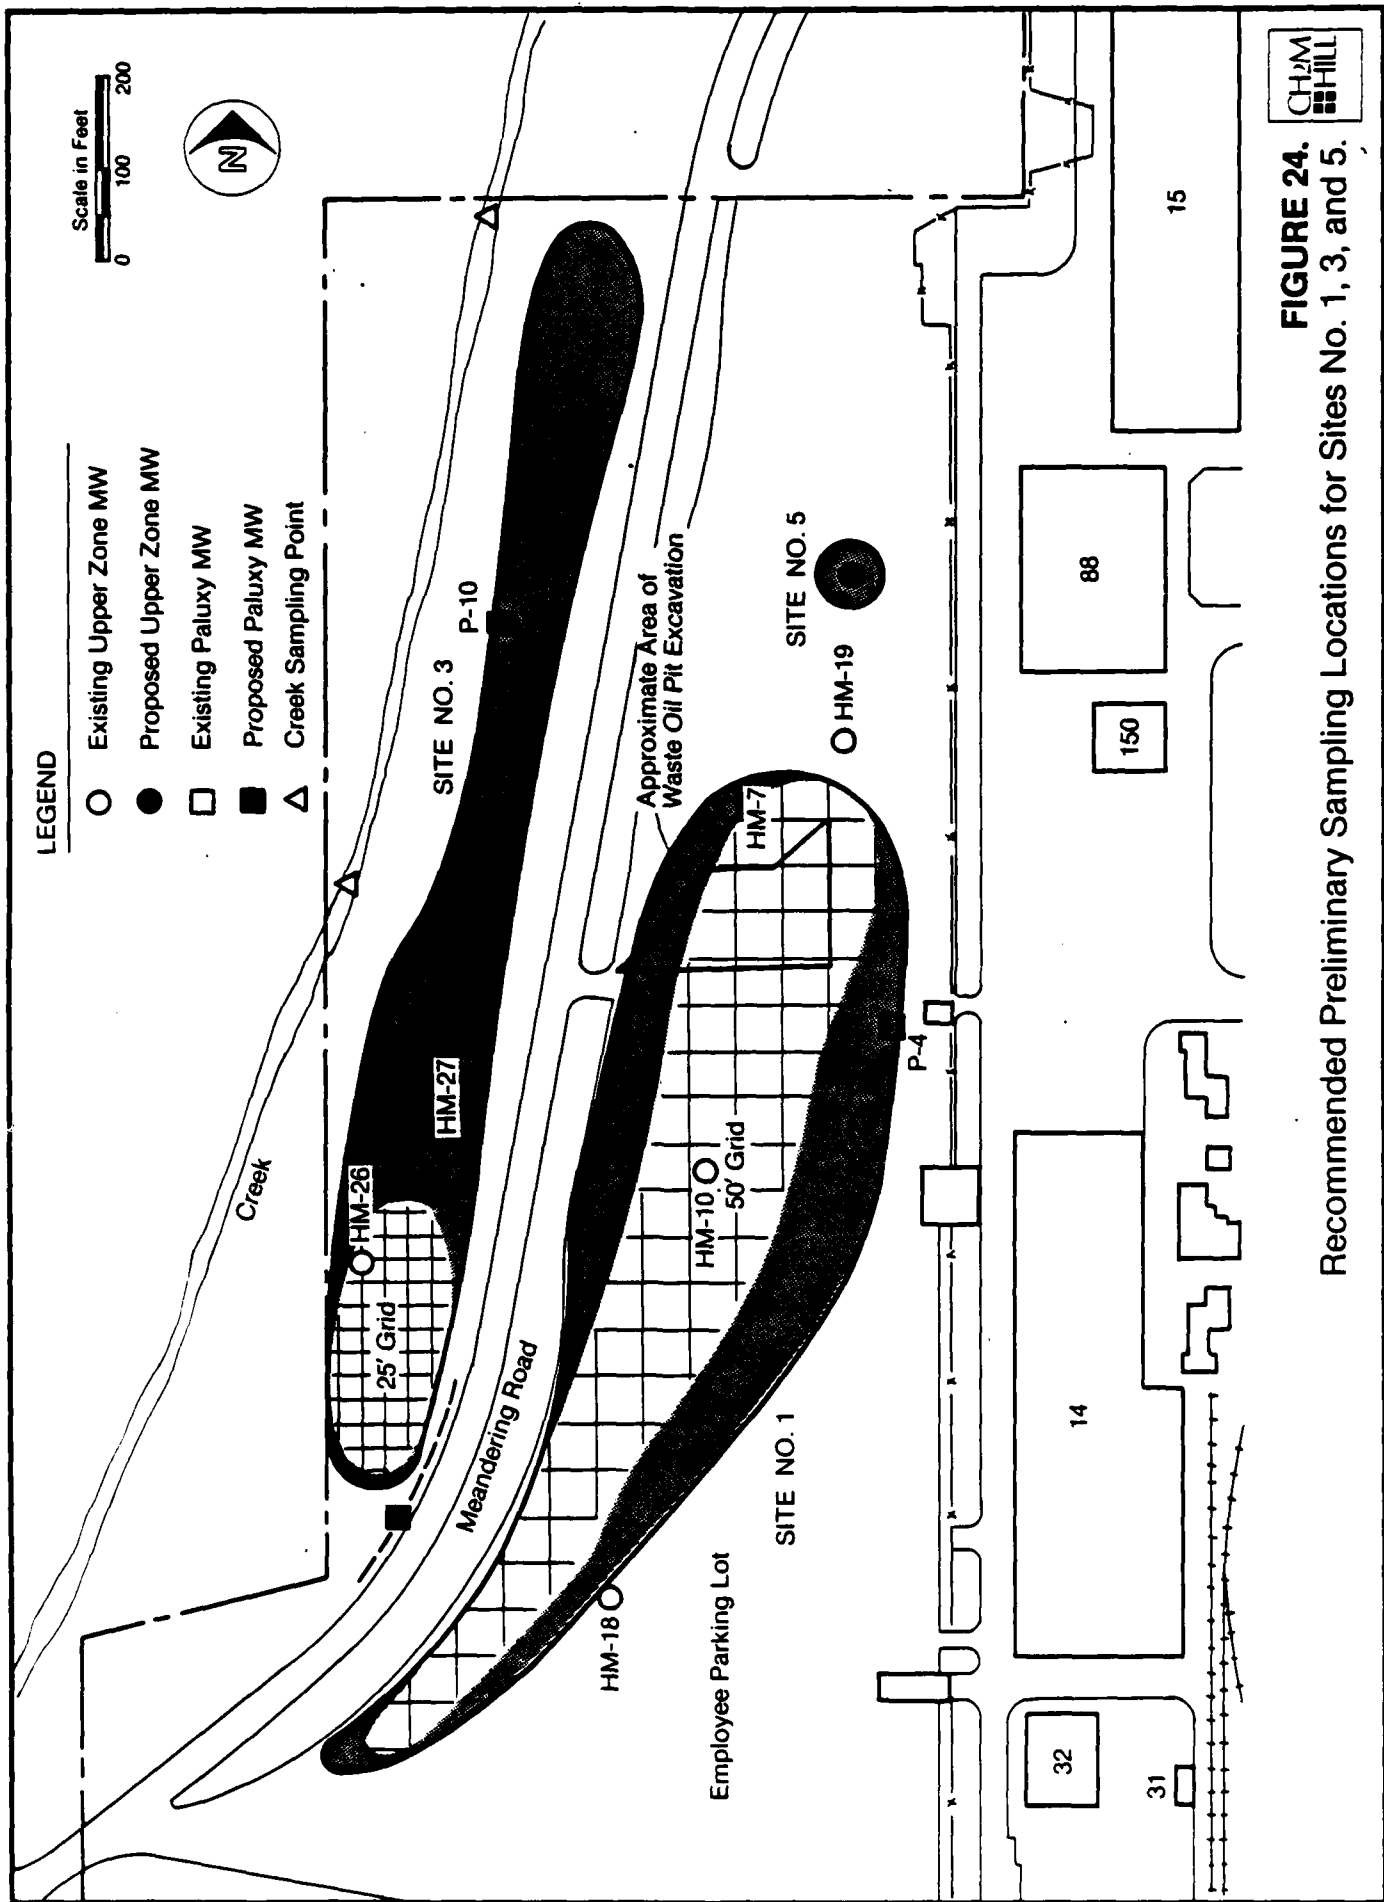
**FIGURE 24.**  
Recommended Preliminary Sampling Locations for Sites No. 1, 3, and 5.

Soil borings are recommended to delineate the remaining area of contamination within the landfill. A grid system of borings located on 50-foot centers as shown in Figure 24 is proposed, to define the areal limits of the

contaminated fill. Installation of the boreholes, sampling and analysis of soil samples, should be conducted as outlined above (Section VI.B.3.a., "General").

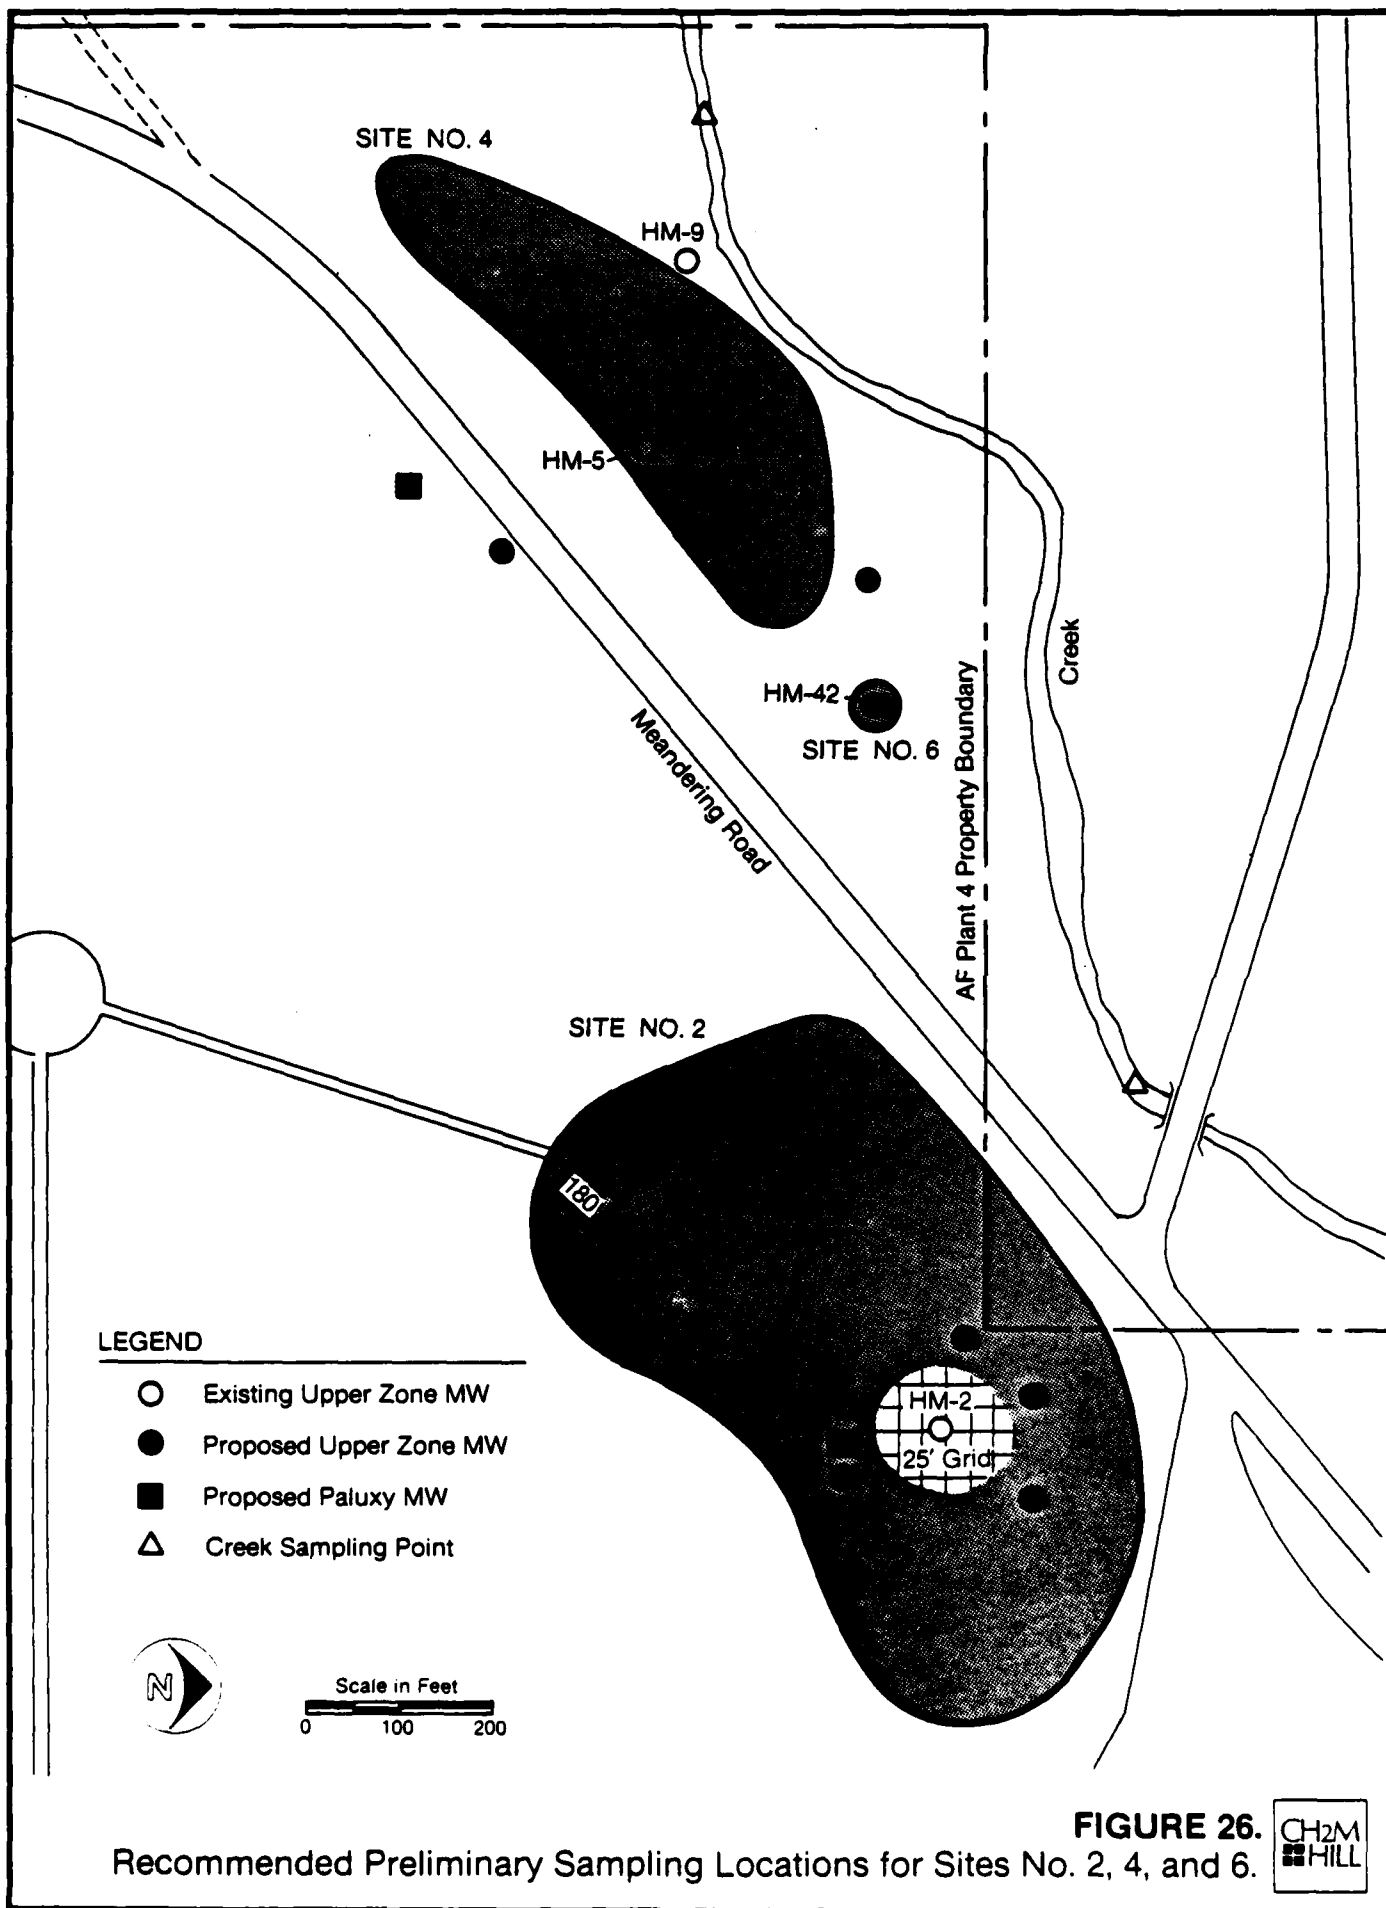
One borehole should be converted to an upgradient monitor well and three boreholes should be converted to downgradient monitor wells as shown approximately in Figure 26.

One downgradient Paluxy monitor well should also be installed. This well should be constructed into the upper sand member of the Paluxy Formation. If subsequent analyses of ground water indicate contamination in the upper sand member, a second Paluxy well should be installed into the lower sand member.

Ground-water samples from the proposed upper zone wells and the proposed Paluxy well should be analyzed in accordance with Table 27. Continued monitoring should be dependent on the findings of the first sample event.

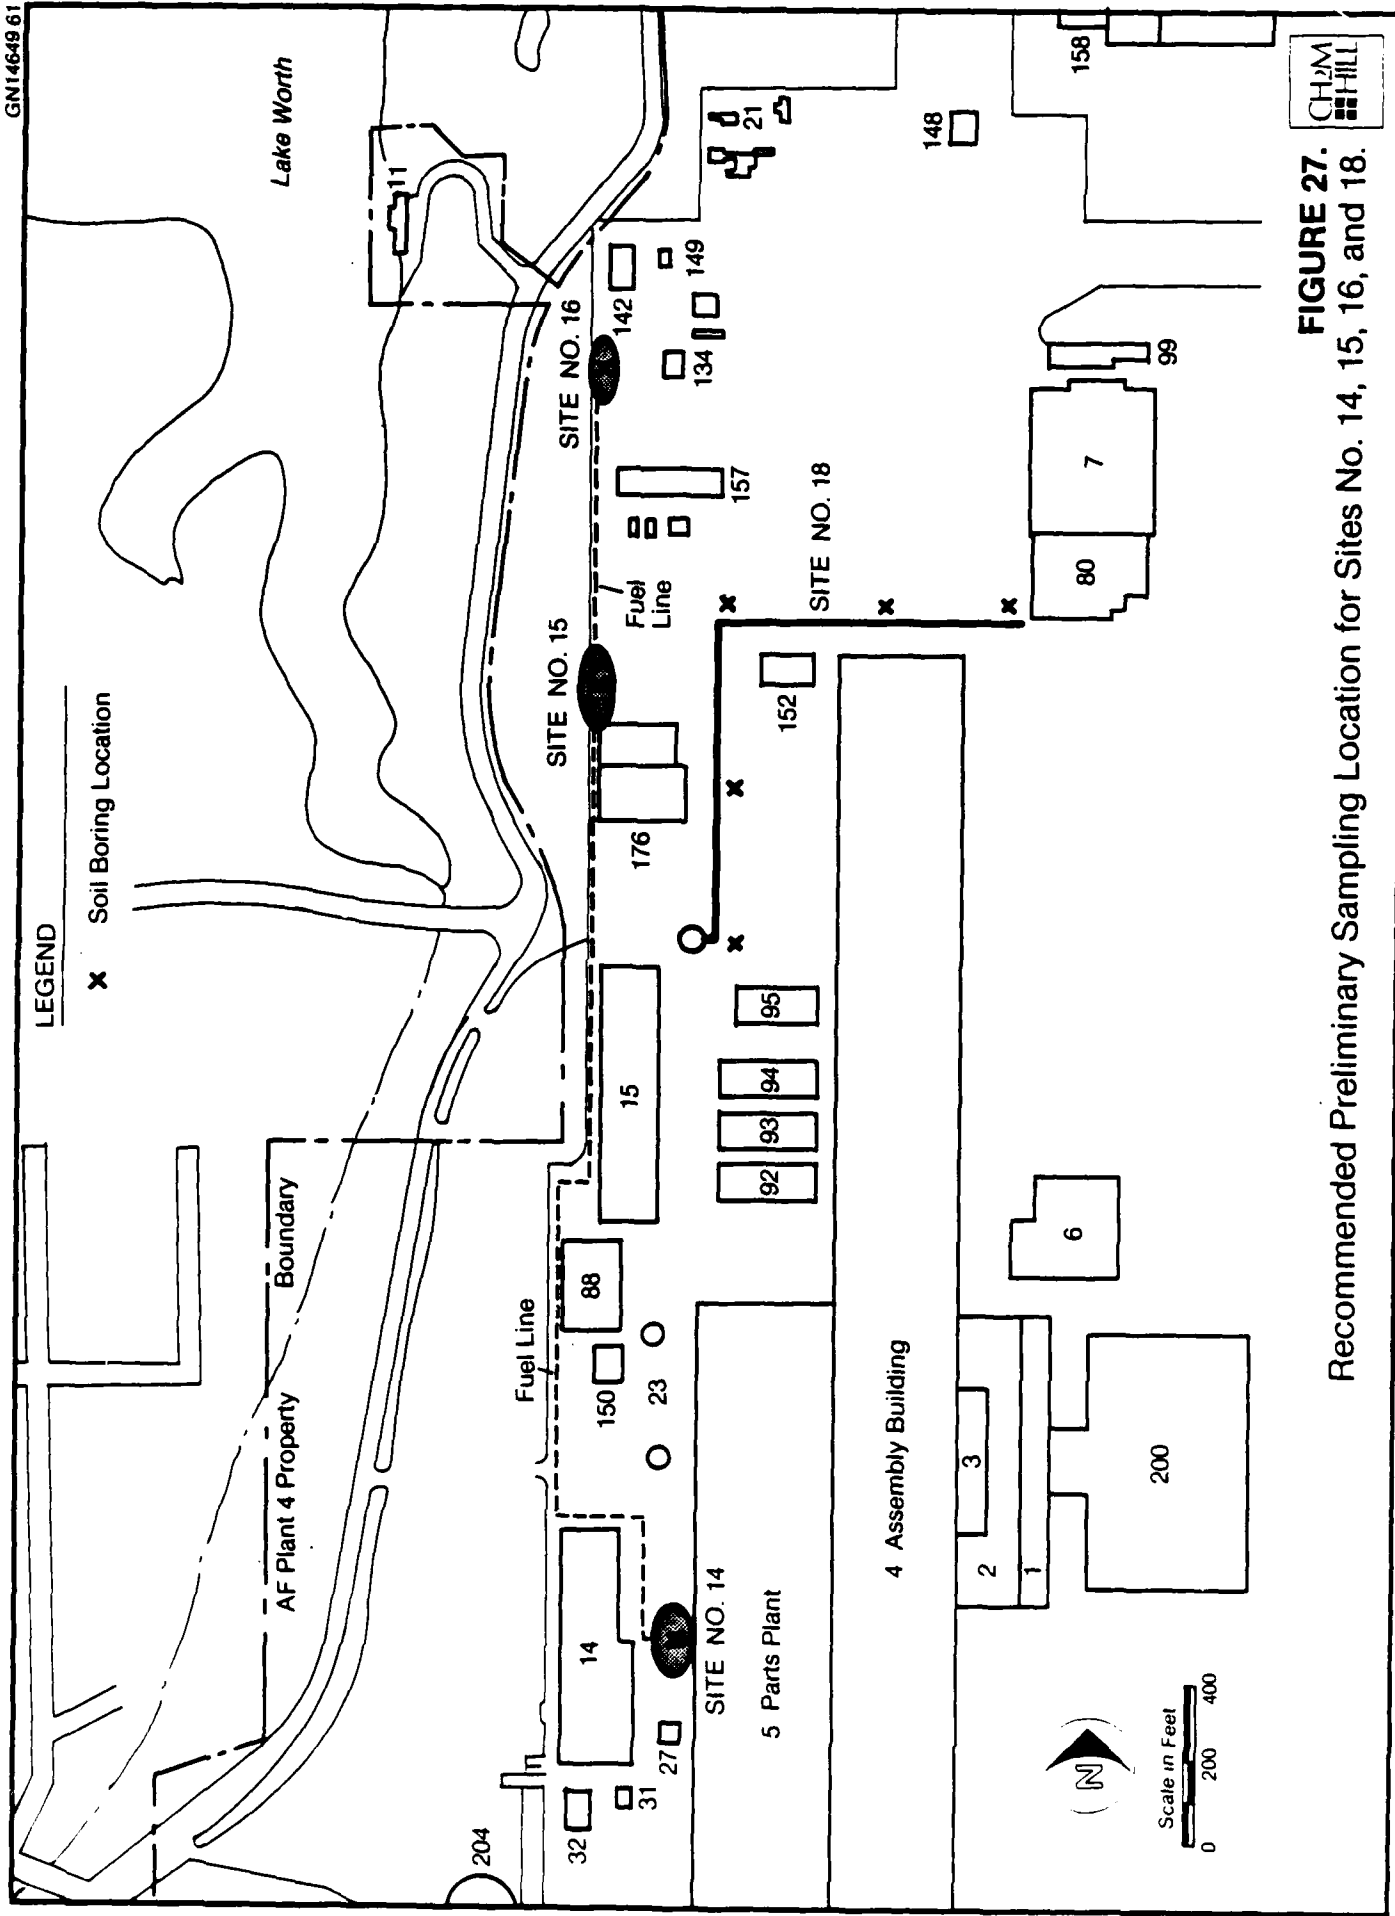
**FIGURE 27.**  
Recommended Preliminary Sampling Location for Sites No. 14, 15, 16, and 18.

The well should be sampled and analyzed in accordance with Table 27. During the first round of sampling, after the well has been pumped down and allowed to recover, the presence and estimated thickness of a free product fuel lens should be determined. This can be accomplished through the use of a special steel measuring tape coated with water and oil-finding pastes.

If findings indicate that saturation below the fuel line exists and may extend over much of the pipeline, a program should be developed to investigate the entire fuel line and subsurface.

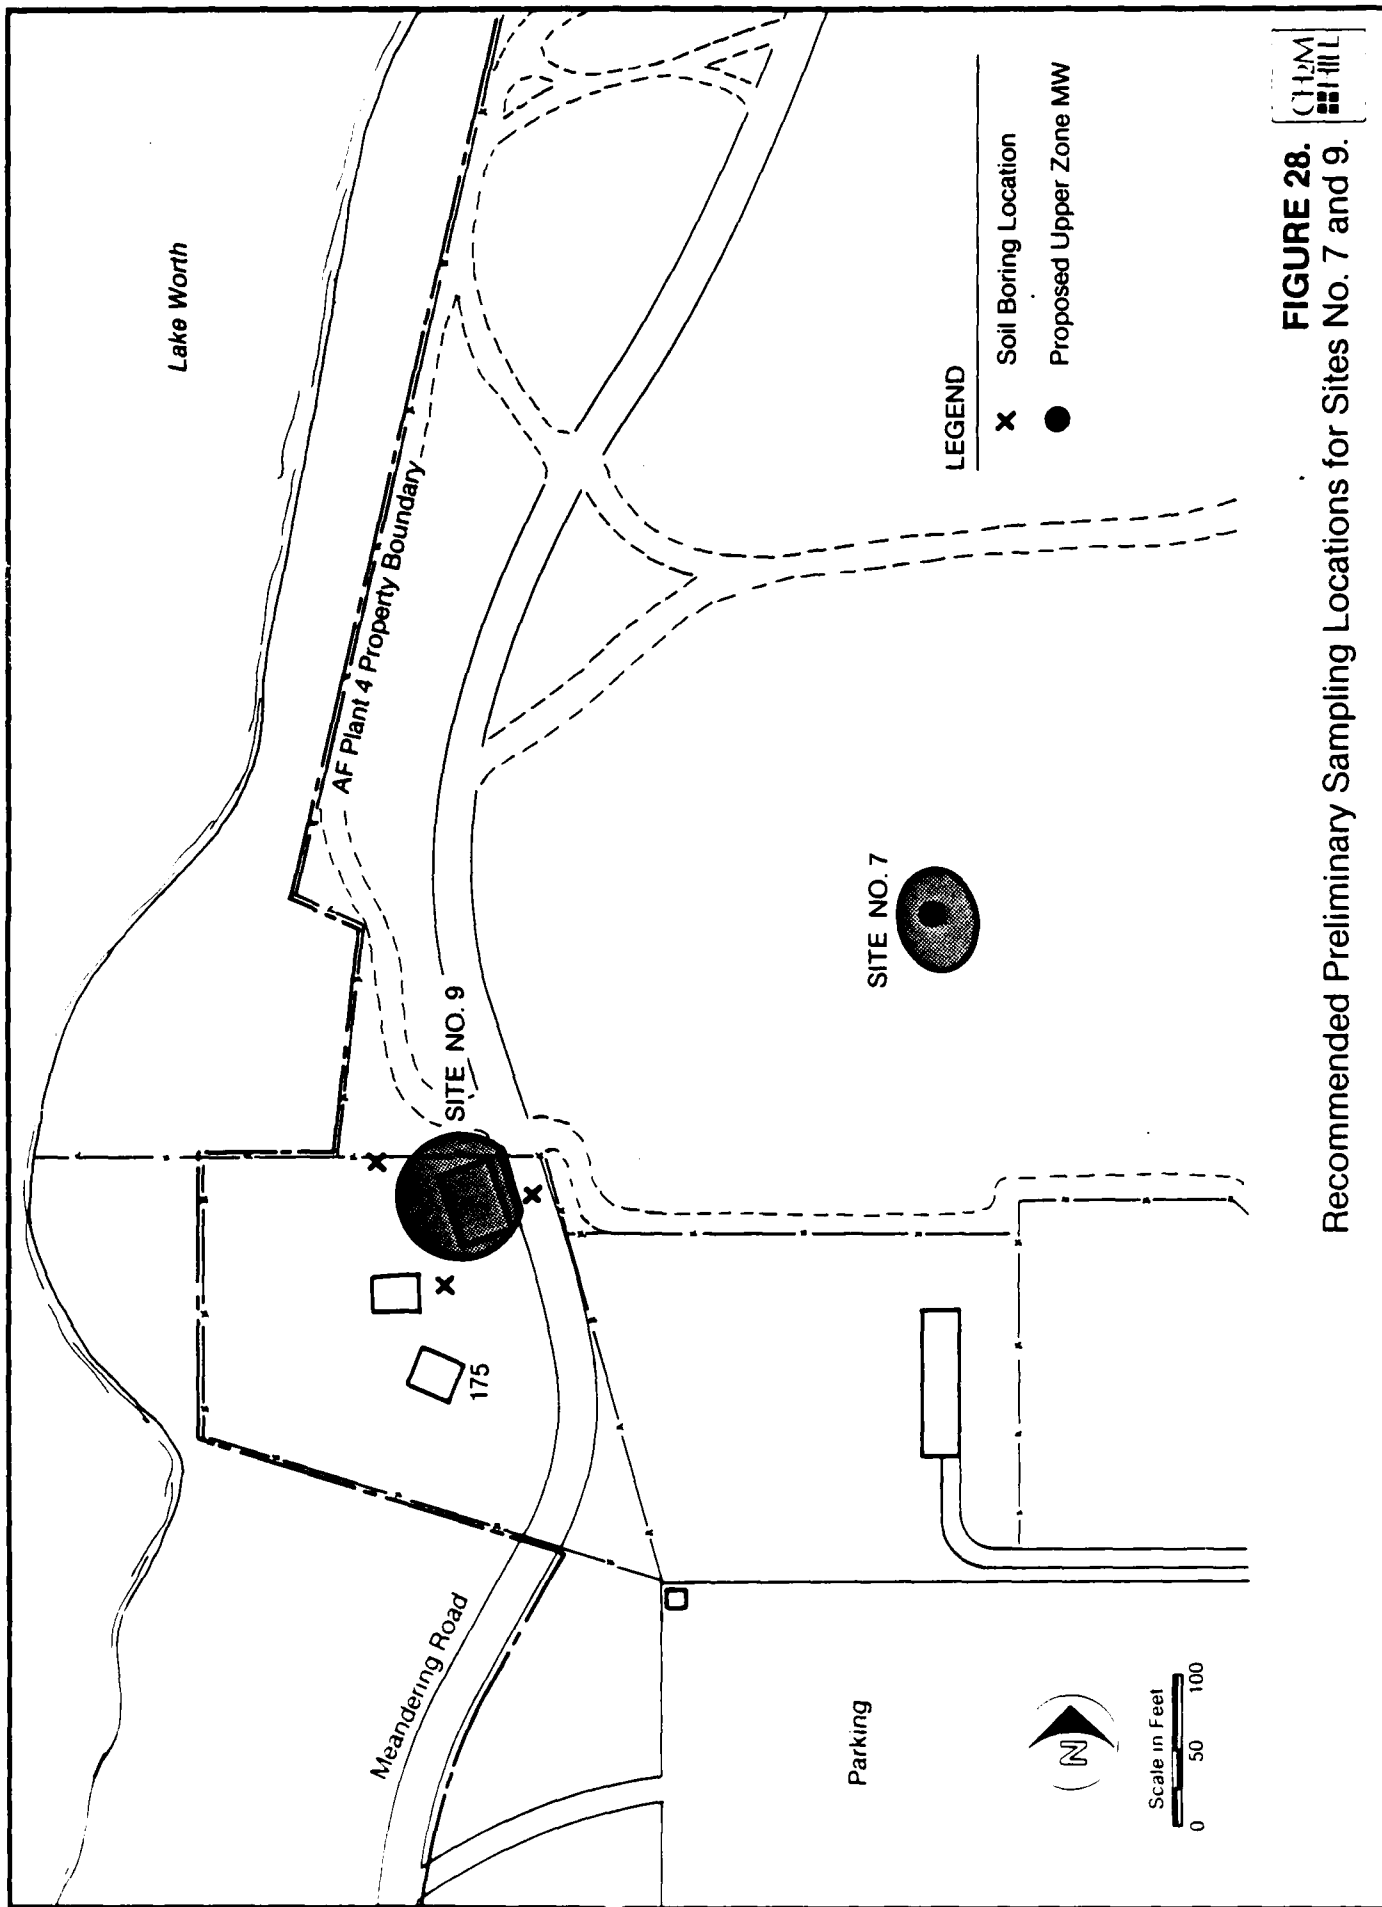
**FIGURE 28.**  
Recommended Preliminary Sampling Locations for Sites No. 7 and 9.

A single soil boring installed in the approximate center of each site is recommended (Figures 24 through 28). This soil boring should be converted to an upper zone monitor well. Reference to General Dynamics aerial photographs should aid the Phase II contractor in establishing the location for the boreholes. Sampling and analysis of soil samples should be conducted as outlined in Section VI.B.3.a., "General". Based on soil boring analyses, upgradient and downgradient upper zone monitor wells should be installed to monitor ground-water quality and water elevations. The number and precise location of these wells should be established by the Phase II contractor.
